**DELAWARE RIVER BASIN  
LOWER BIRCHWOOD LAKE DAM**

NDI NO. PA-00403  
DER NO. 52-145

**PHASE I INSPECTION REPORT  
NATIONAL DAM INSPECTION PROGRAM**

BY  
Berger Associates, Inc.  
Harrisburg, Pennsylvania  
JUNE 1980

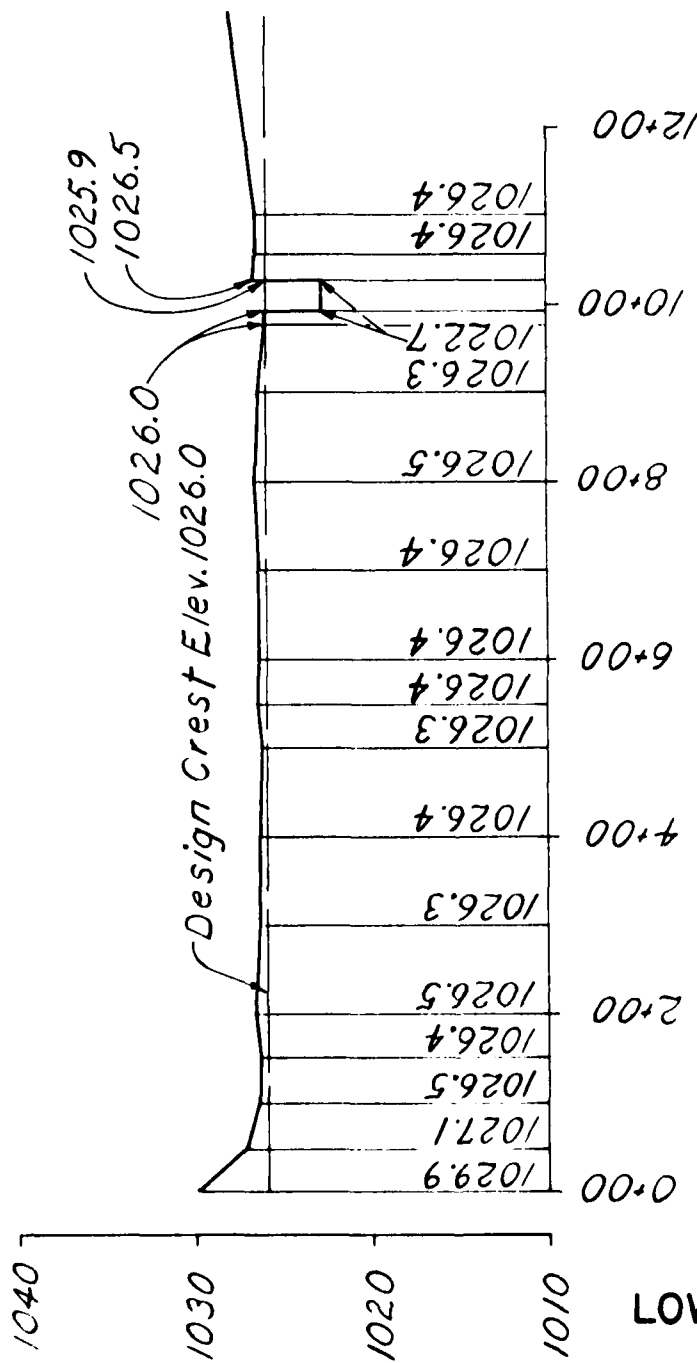
**LOWER BIRCHWOOD  
LAKE DAM  
PA.- 00403  
INSPECTION SURVEY  
PLATE A-II**

this area (Photograph No. 6). It is recommended that this surface water be drained away from the toe of the dam. The horizontal alignment of the dam is curved (see Plate A-I). The vertical profile of the crest of the dam, as surveyed during this inspection, (Plate A-II) indicates that the top of the dam, with the exception of one area adjacent to the right spillway wall, is at least 0.3 feet higher than the design crest elevation.
